U.S. Naval Hospital, Ward D (Bldg.10) Park Boulevard, Balboa Park San Diego San Diego County California

HABS No. CA-1548-H

HISTORIC AMERICAN BUILDINGS SURVEY ARCHITECTURAL DATA FORM

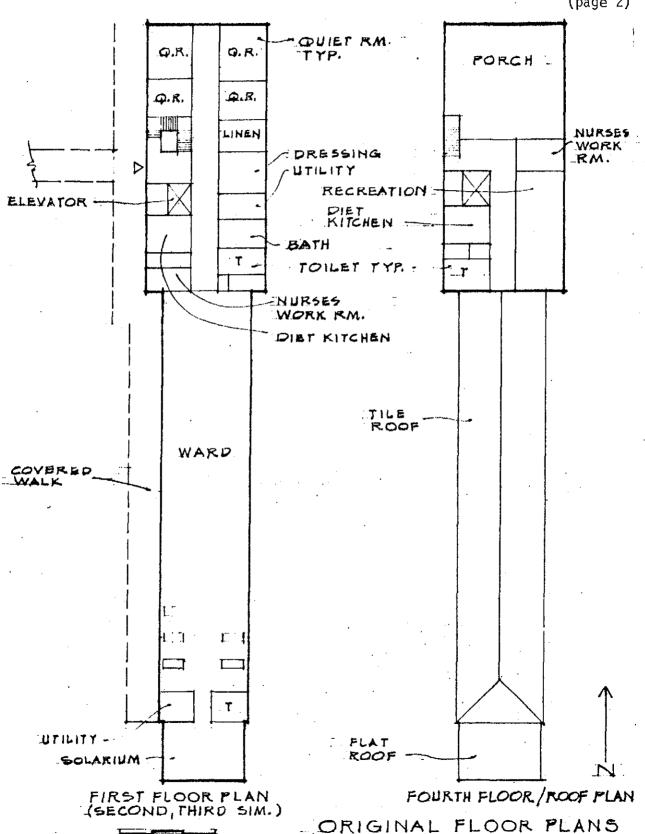
WARD D(BLDG 10) HABS Nº CA-1548 H (page 2)

INTERIOR FEATURES DF NOTE: (PLEASE SEE SKETCHED FLODR PLAN ON SEPARATE PAGE) Floor plan same as Building 9 only reversed. Gross floor area 30,650 square feet. Ward accommodates 172 beds. MAJOR ALTERATIONS AND ADDITIONS WITH DATES: Sketch of existing floorplan shows extent of major changes. Covered walks added, perhaps in 1936. Basement passageway to Bldgs. 10 and 14 in 1929. Corpsmen's Dorm in basement south end 1929. Third floor virology lab 1972. Later dropped ceilings and fluorescent lighting when converted later to office use. PRESENT CONDITION AND USE: Adequately maintained with no eye to historic preservation. Exterior has had only minor changes. First floor has offices at north end and labs at south end. Second and third floor have labs, fourth floor offices. AODITIONAL INFORMATION: Site does not slope steeply east in contrast to the sites of other buildings on east side of main complex, Buildings 4 and 9. SOURCES OF INFORMATION: Original construction drawings; Architectural and Historical

WARD & SIMILAR BUT REVERSED
